MÁRCIA DANTAS BRAGA
Rio de Janeiro, Brazil
marcia@marciabraga.arq.br

THE CONSERVATION OF THE STATUE OF *CHRIST THE REDEEMER*, RIO DE JANEIRO, 2010

Keywords: mosaic restoration, federal heritage, laboratory analyses, outdoor sculpture

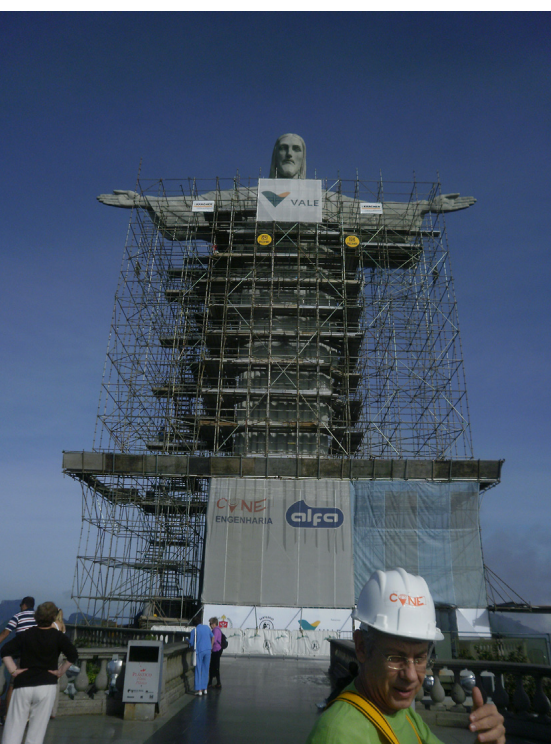
Figure 1

The figure surrounded by scaffolding

The erection of the scaffolding was initiated in February 2010 by the company Rohr. This time the operation included the construction of a stair tower up to the height of the shoulders and the placement of work platforms around fifty percent of the statue. It was completed in five weeks (Figure 1).

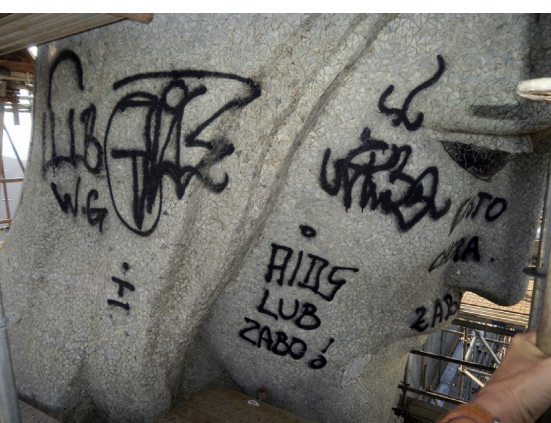
Figure 2

The monument was closed for a six-day period when heavy rains caused barriers in the Tijuca National Park to break. During this time, vandals were able to reach the monument and leave graffiti all over the face, chest, and the front part of the right arm. (Figure 2) All the graffiti was photographically documented and then covered with cement laitance to preserve the dignity of the monument until further measures could be taken. The stages for the removal of the graffiti followed the sequence described below:

Graffiti on the face

- dry removal of the cement laitance using plastic bristle brushes and oakum;
- localized application of a paste stripper over the black spray paint by paintbrush with light friction. The principal active ingredients of the stripper are: methylene chloride, methyl alcohol and ammonium hydroxide, in a mixture of cellulose ether and paraffin esters;

- removal of the paste stripper after approximately five minutes with dry cotton, taking care not to spread the paint;
- application of mineral spirit more broadly over the vandalized surface using cotton swabs. This dilutes the stripper impregnated with the graffiti ink, facilitating the mechanical removal of the residue;

- cleaning of the surface with a ten percent solution of neutral detergent. This ensures the more complete removal of the graffiti and facilitates the repetition of the process in areas where traces remain;

- rinsing using plastic bristle brushes.

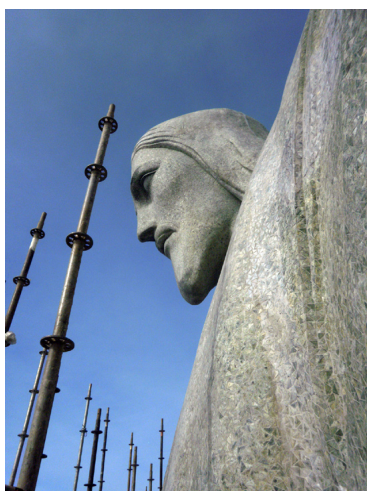
The pressure of the model DE 4002 device was calibrated to remain between three and four bars. The steam or water jet was delivered through the head of a nylon brush rubbed against the surface. The cleaning was carefully carried out in order to remove the biological patina from the tesserae and grout. The areas where the moisture accumulated, such as under the chin and the arms, and in the south and west sides which are exposed to storm winds, displayed marked superficial deterioration, thus indicating the chemical action of fungi in the production of acids.

Figure 3
Cleaning of the right arm

The cleaning of the statue was carried out with steam and water at approximately 70° Celsius. Kärcher supplied the equipment and the personnel who operated the equipment (Figure 3).

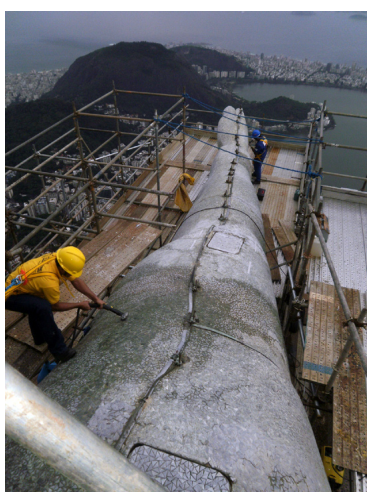
Figure 4
Opening of a crack in the side of the head

Following the cleaning, it was possible to characterize in further detail the cracks that had been previously identified. These cracks were no greater than three millimeters wide and were opened using small electric shaft drills with heads two and half millimeters in diameter and small chisels. The depth proved to be no greater than one centimeter. The removal of the cracked tesserae was also carried out using the same methodology. This resulted in a minimum substitution of pieces (Figure 4).

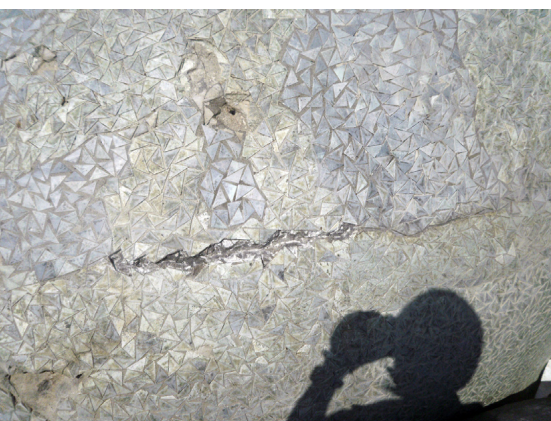
Figure 5
Replacing of tesserae

The replacement tesserae were used primarily over cracks, in the missing areas located in the top of the head, on the tips of the fingers and in the sample collection sites. (Figure 5) The principal difficulty in this replacement process concerned the use of tesserae of the same color as the originals.

The selection of the tesserae to be used was carefully undertaken. Approximately eighty percent of the replacement tesserae was discarded in order to achieve satisfactory chromatic adjustment. It is estimated that less than 5% of the original tesserae was replaced. The new tesserae came from the same region as the originals, in the state of Minas Gerais. Some discussions took place regarding the additions to old interventions, which were of a different color than the original. In these areas it was decided to use

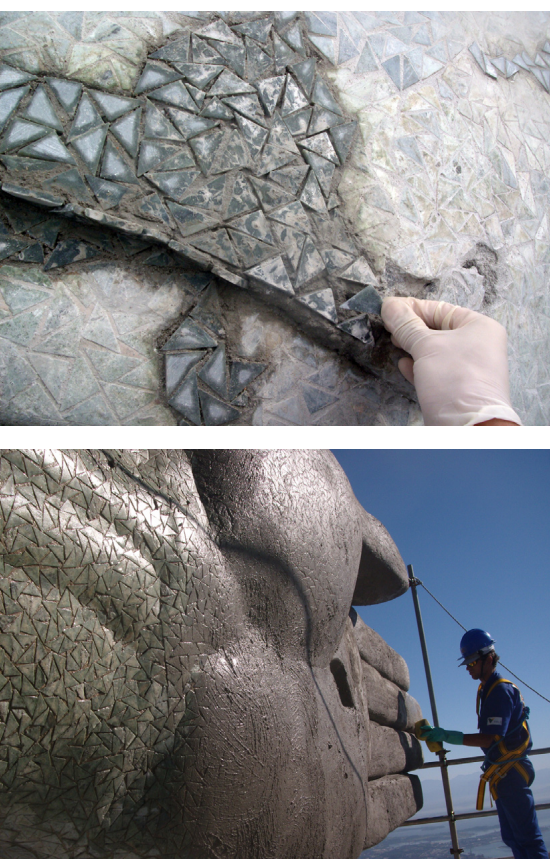
Figure 6
During re-grouting

The entire re-grouting was carried out by applying the grout with a plastic spatula and soon after removing the excess with wet sponges. In addition to its purpose of preserving the monument, it achieved aesthetic homogeneity of the surface (Figure 6). It is important to note that this procedure left residues on the tesserae (principally the most worn ones) and that it caused a lightening of the surface. This lightening was much less than that observed following the cleaning and the removal of the microorganisms. The grout is an element that suffers continual wear, generally greater than that of the tesserae. Its existence can be considered temporary, like that of the waterproofing material used subsequently. Its application does not represent a permanent intervention like that of the replacement of the tesserae. The method of applying the grout over the entire surface and removing the excess almost immediately was the best option we could come up with in the circumstances.

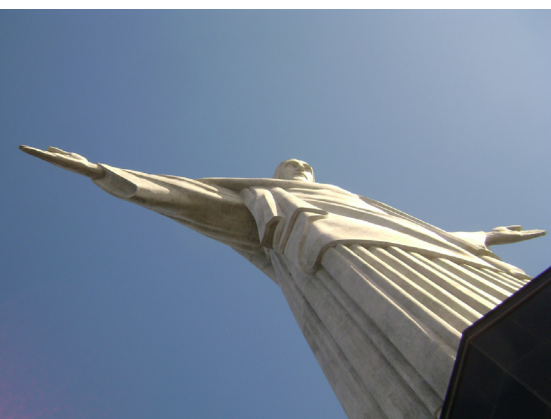
Figure 8
The statue after conservation, June 2010
